**CAL/APT PROGRAM — ASPHALT TREATED PERMEABLE  
BASE (ATPB)**

**Laboratory Testing, Performance, Predictions, and Evaluation of  
the Experience of Caltrans and Other Agencies**

J. Harvey, B. Tsai, F. Long, and D. Hung

July 1999

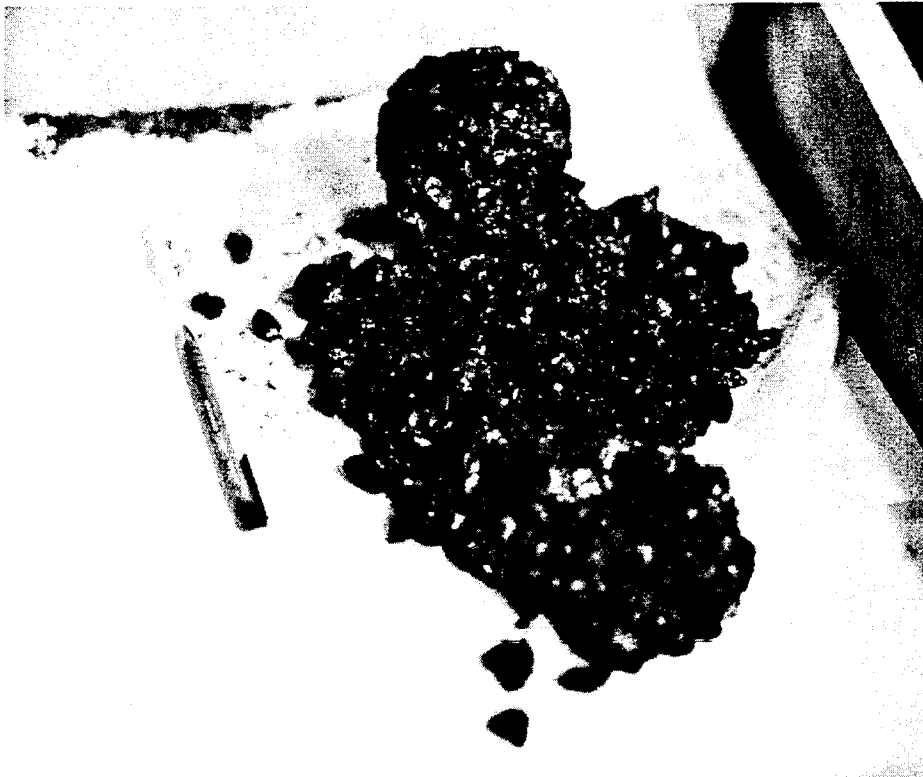
**Figure 4.10. Goal 1 ATPB Specimen Failed in Saturated Permanent Deformation Test.**
